Water on the wrong side of the levee?

Full Mitigation Best Practice Story

Snohomish County, Washington

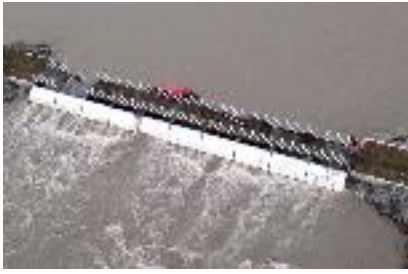
The "Old Stilly Gate" draining away floodwater south of Stanwood, 2 pm Friday, January 9, 2009.

In January 2009, sustained overtopping of the mainstem Stillaguamish River below Silvana posed the first test of the new Old Stilly Gate. After the river crested at Stanwood in the evening of January 8th, the floodgate was able to discharge an estimated 80 million cubic feet – or more than 600 million gallons – back to the river in just 36 hours. Marine Drive was reopened and flooded farmland was drained in less than half of the time – usually three to four days – than it took in previous floods. The BNSF was able to run their trains within 24 hours, and railroad officials, as well as upstream property owners, were pleased with the successful operation of the floodgates. They all agreed with Max Albert that the gates had passed their first test with flying colors.

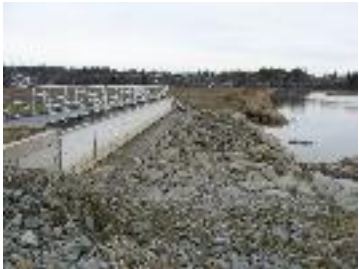
After the flood (February 21, 2009)
